Rockwell International

No: . UU3-27510/274-044/25-74-00

Subject: . Corrosion of MGCS Frame at EMI  
Gasket Interfaces

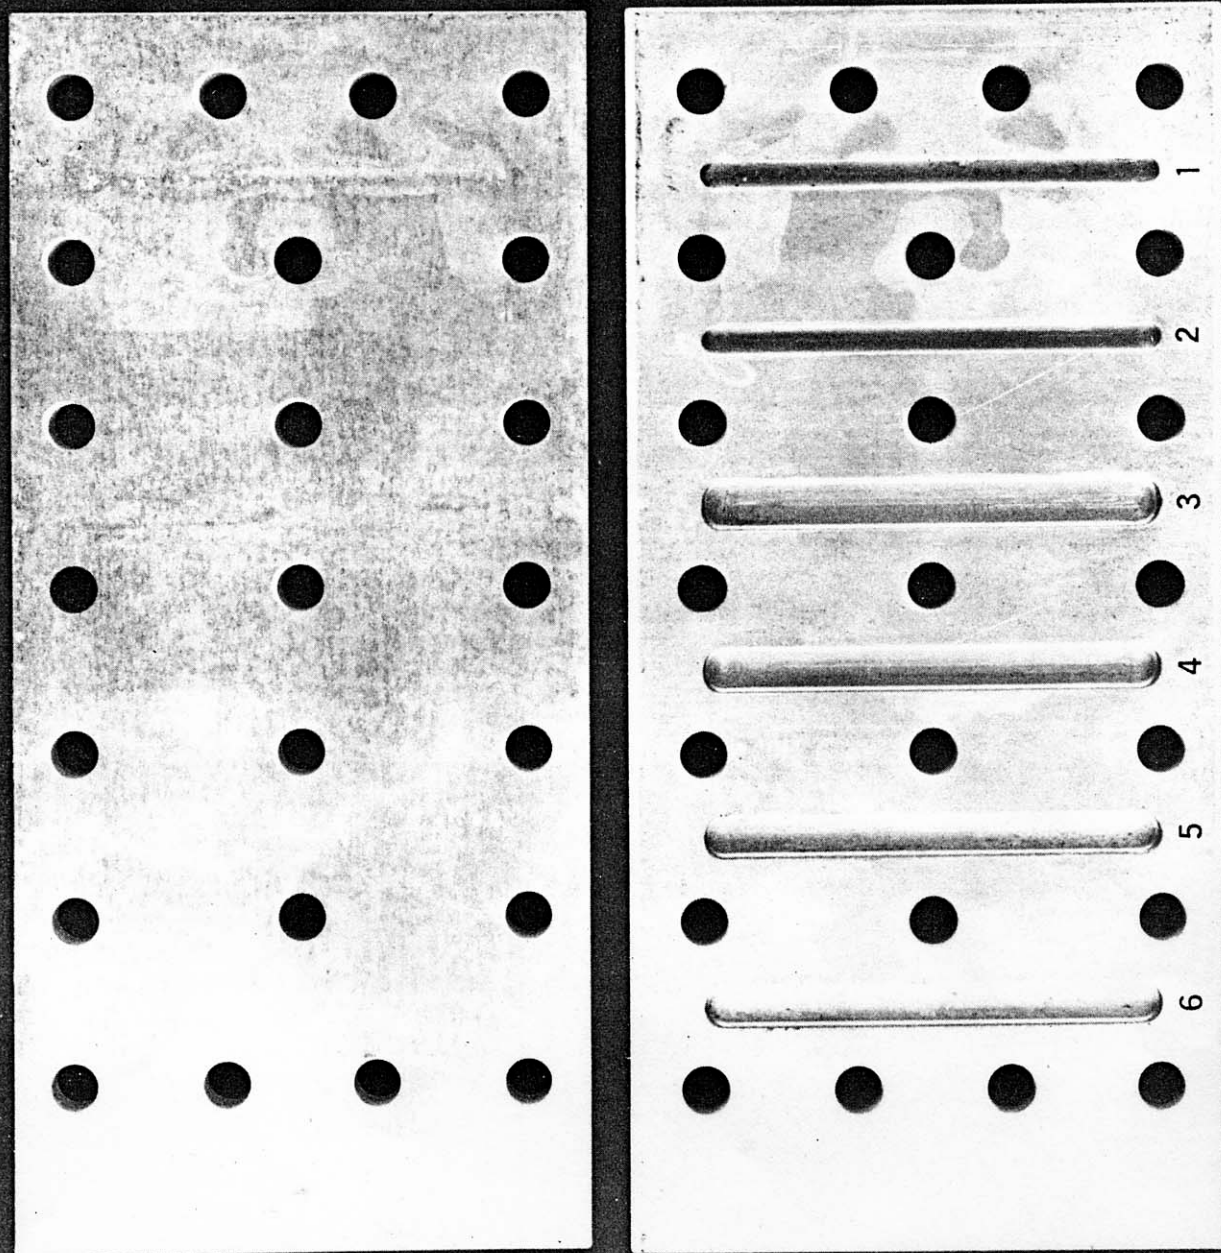
FIGURE 4. AN UNSEALED FIXTURE OPENED AFTER 24 DAYS OF ALTERNATE IMMERSION TESTING.

An unsealed fixture, after alternate immersion testing, is shown open in Figure 4. The gaskets on the right hand side of the figure are numbered, as are the grooves on the fixture, to indicate where the gaskets were mounted. Gasket 1 is a Spira gasket with bare copper edges. Gaskets 2 and 3 are Spira gaskets with retinned edges; 3 also has a silicone rubber seal bonded to one side. Gaskets 5 and 6 are Ferrex gaskets, retinned and not retinned, respectively. Groove No. 4 on the fixture held no gasket.

This fixture shows evidence of corrosion in the grooves and on the cover plate where both Ferrex gaskets (5 and 6) and the Spira gasket with bare copper edges (1) were mounted. Three small isolated pits were found on the cover plate above each of the Spira gaskets with retinned edges; the grooves were unaffected. No corrosion was detected at the empty groove (4).

For FSED II hardware, Ferrex EMI gaskets should be replaced with Spira gaskets with retinned edges. This will insure a flush mating of interfaces and will eliminate the problem now experienced with the installation of Ferrex gaskets. Sealing the EMI interfaces will further enhance corrosion compatibility.

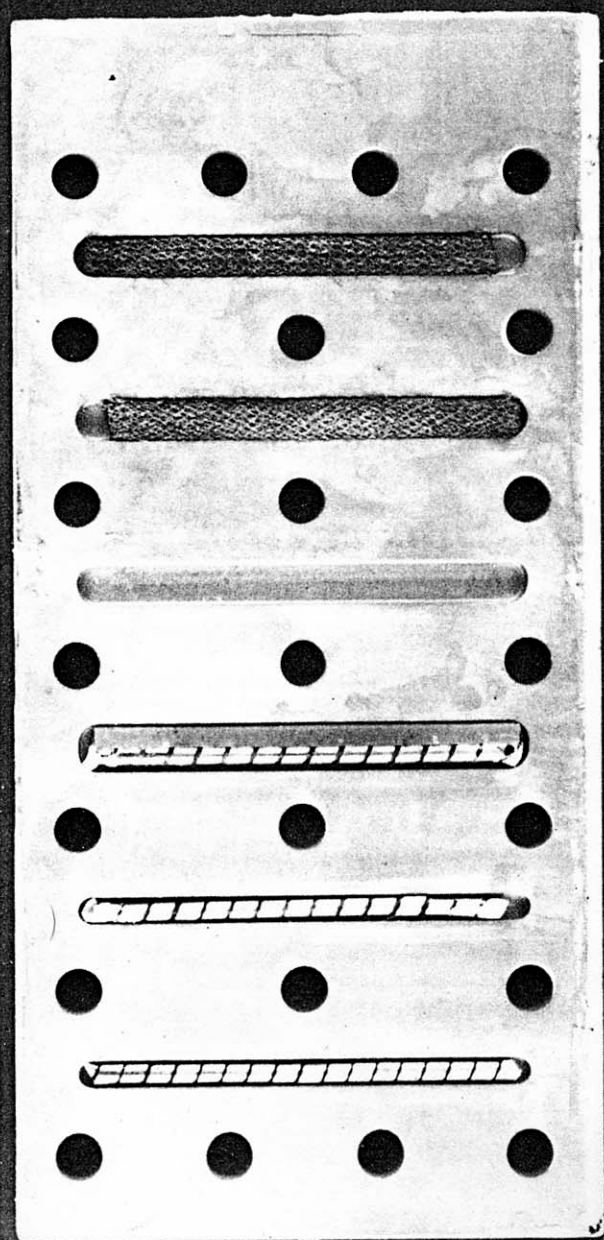
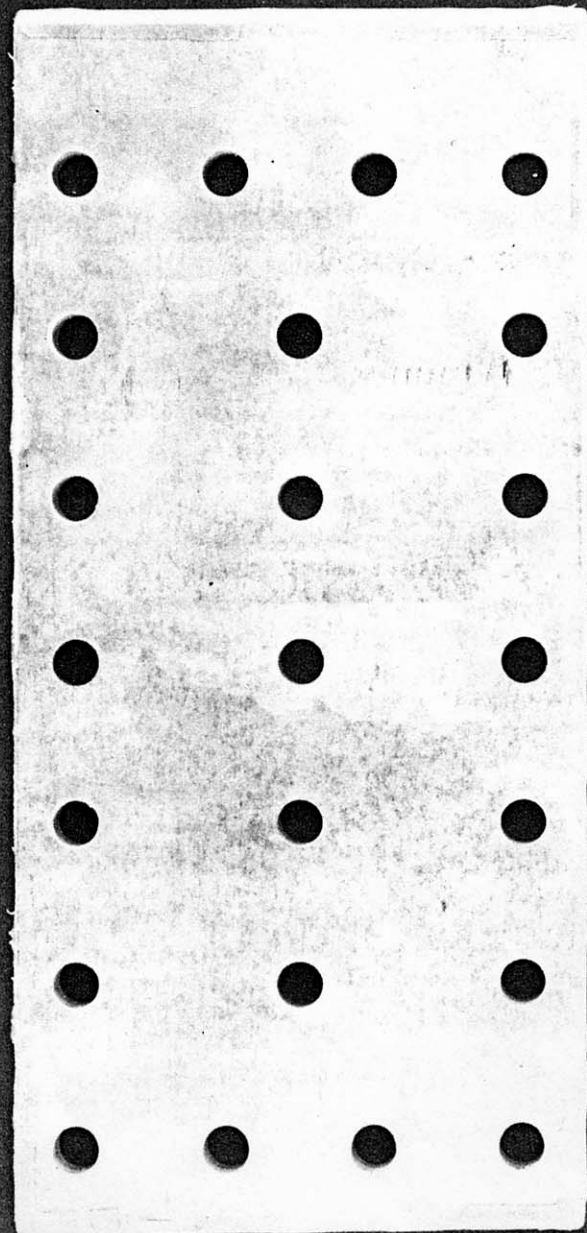
FIGURE 5. A SEALED FIXTURE OPENED AFTER 24 DAYS OF ALTERNATE IMMERSION TESTING. SPIRA GASKETS ARE ON THE LEFT AND FERREX GASKETS ON THE RIGHT.

Figure 5 shows a sealed fixture which was opened after alternate immersion testing. Slight corrosion was found at the Ferrex gaskets (particularly the gasket that was not retinned). No corrosion was observed at the Spira gaskets. There is evidence, however, that water had seeped in through the fastener holes. If the bolt holes had been sealed, there is a good probability that there would have been no corrosion.

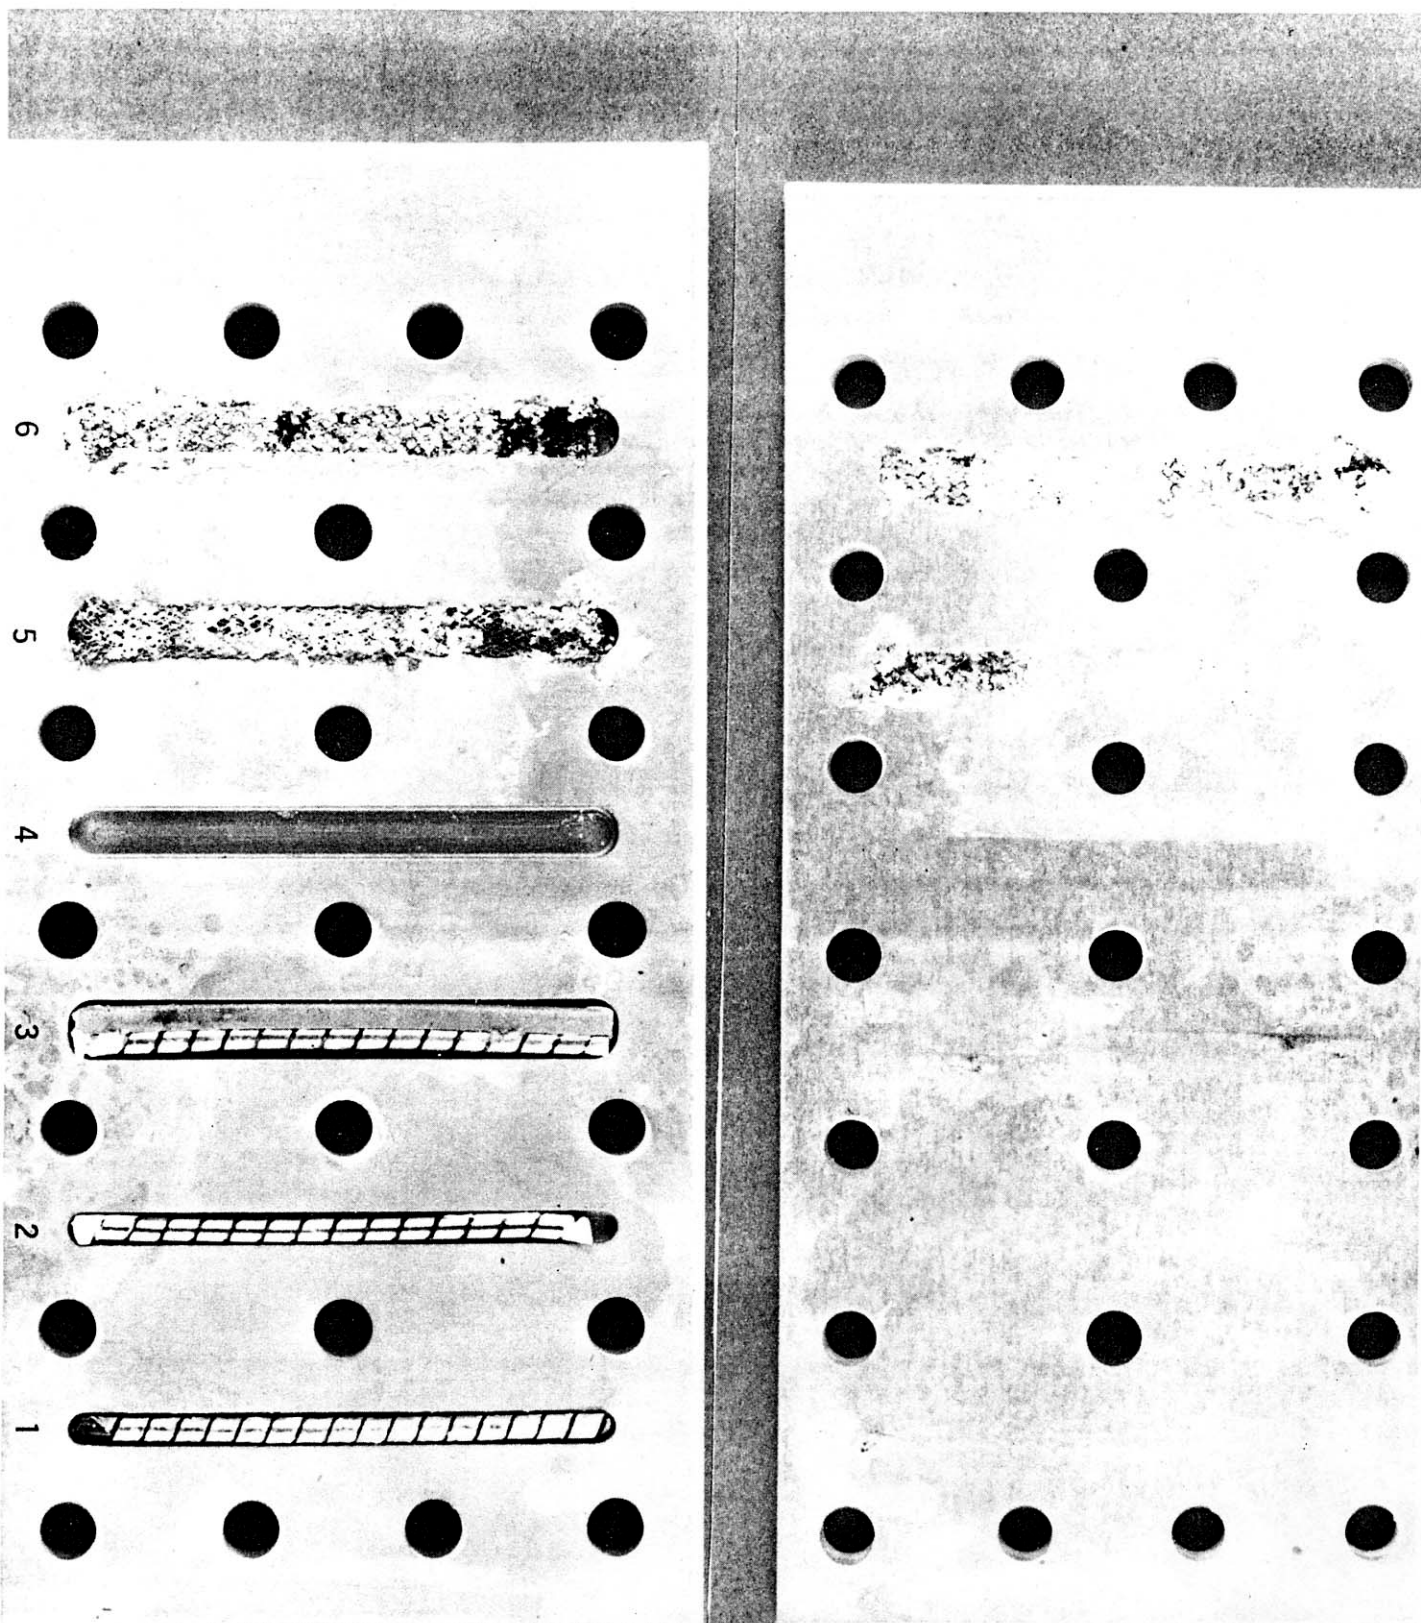
FIGURE 6. OPENED FIXTURE AFTER 14 DAYS OF SALT SPRAY EXPOSURE. CORROSION PRODUCTS HAVE NOT BEEN REMOVED. FERREX GASKETS ARE ON THE LEFT AND SPIRA GASKETS ON THE RIGHT.

An unsealed fixture opened after 14 days of salt spray exposure is shown in Figure 6. The gaskets and corrosion products are still in place. This shows a dramatic difference in corrosion caused by the Ferrex gaskets (5, 6) on the left and the Spira gaskets (1, 2, 3) on the right. The same fixture is shown in Figure 7 after removal of the gaskets and corrosion products. The severity of corrosion and pitting caused by the gaskets is in the following order:

Most severe:	Ferrex gasket, not retinned (6)
	Ferrex gasket, retinned (5)
	Spira gasket, not retinned (1)
Least severe:	Spira gasket, retinned (2,3)

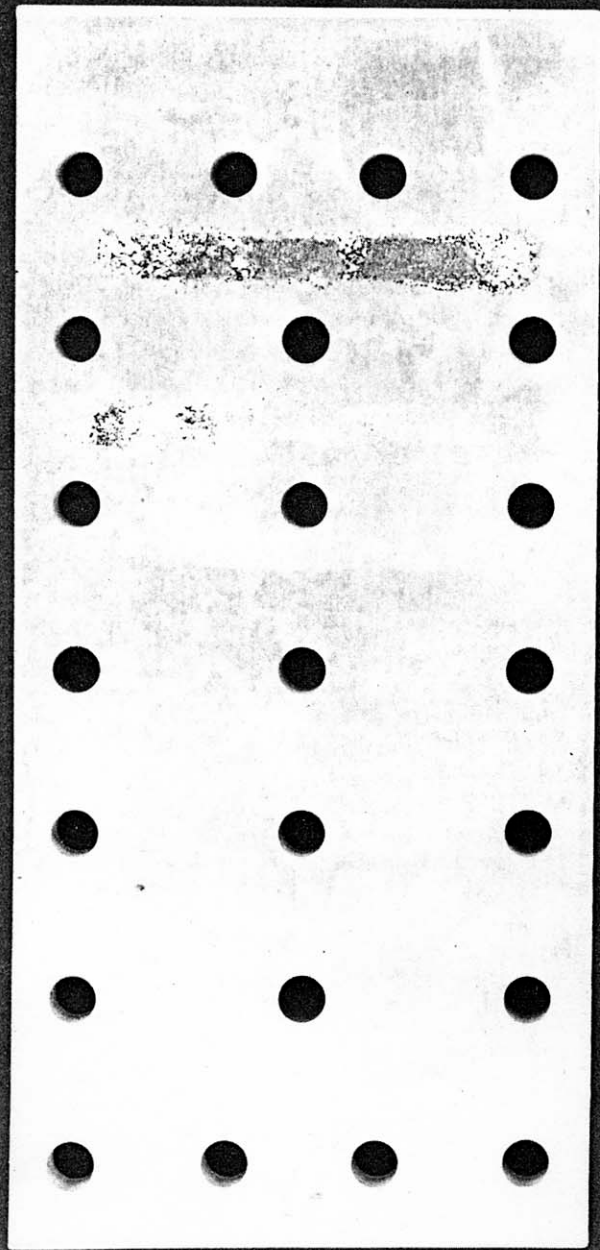
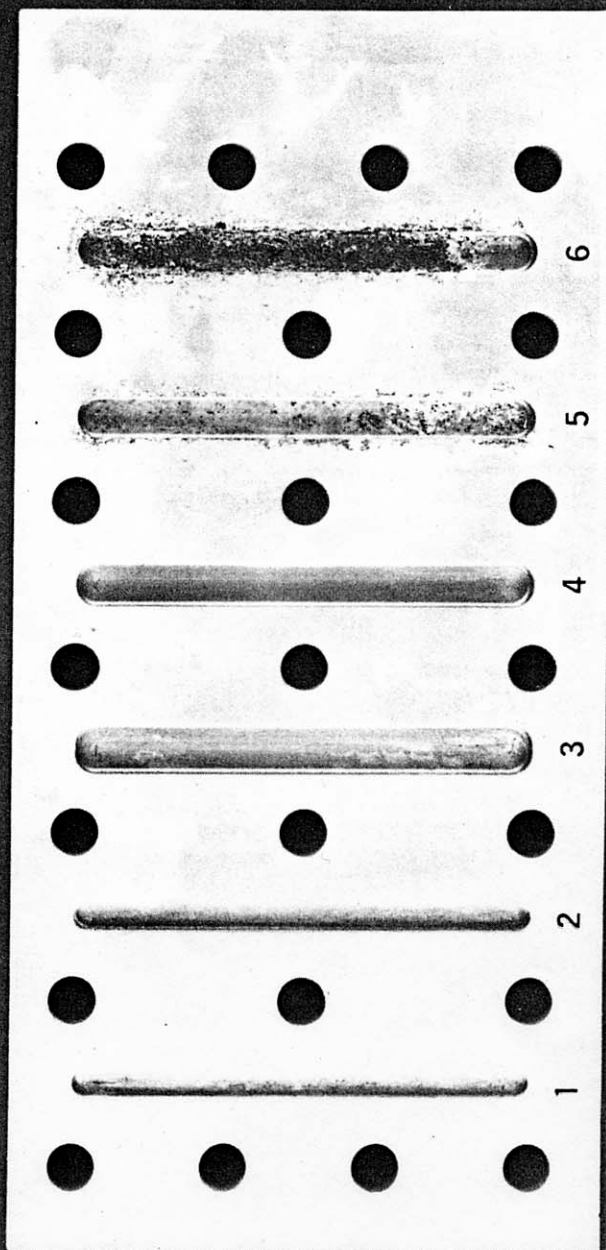
FIGURE 7. SAME AS FIGURE 6 WITH CORROSION PRODUCTS REMOVED.

The retinned Spira gaskets (2,3) were completely compatible with chem filmed aluminum in this test. No corrosion was found in the empty groove (4).
