Rockwell International

No: . UU3-27510/274-044/25-74-00

Subject: . Corrosion of MGCS Frame at EMI  
Gasket Interfaces

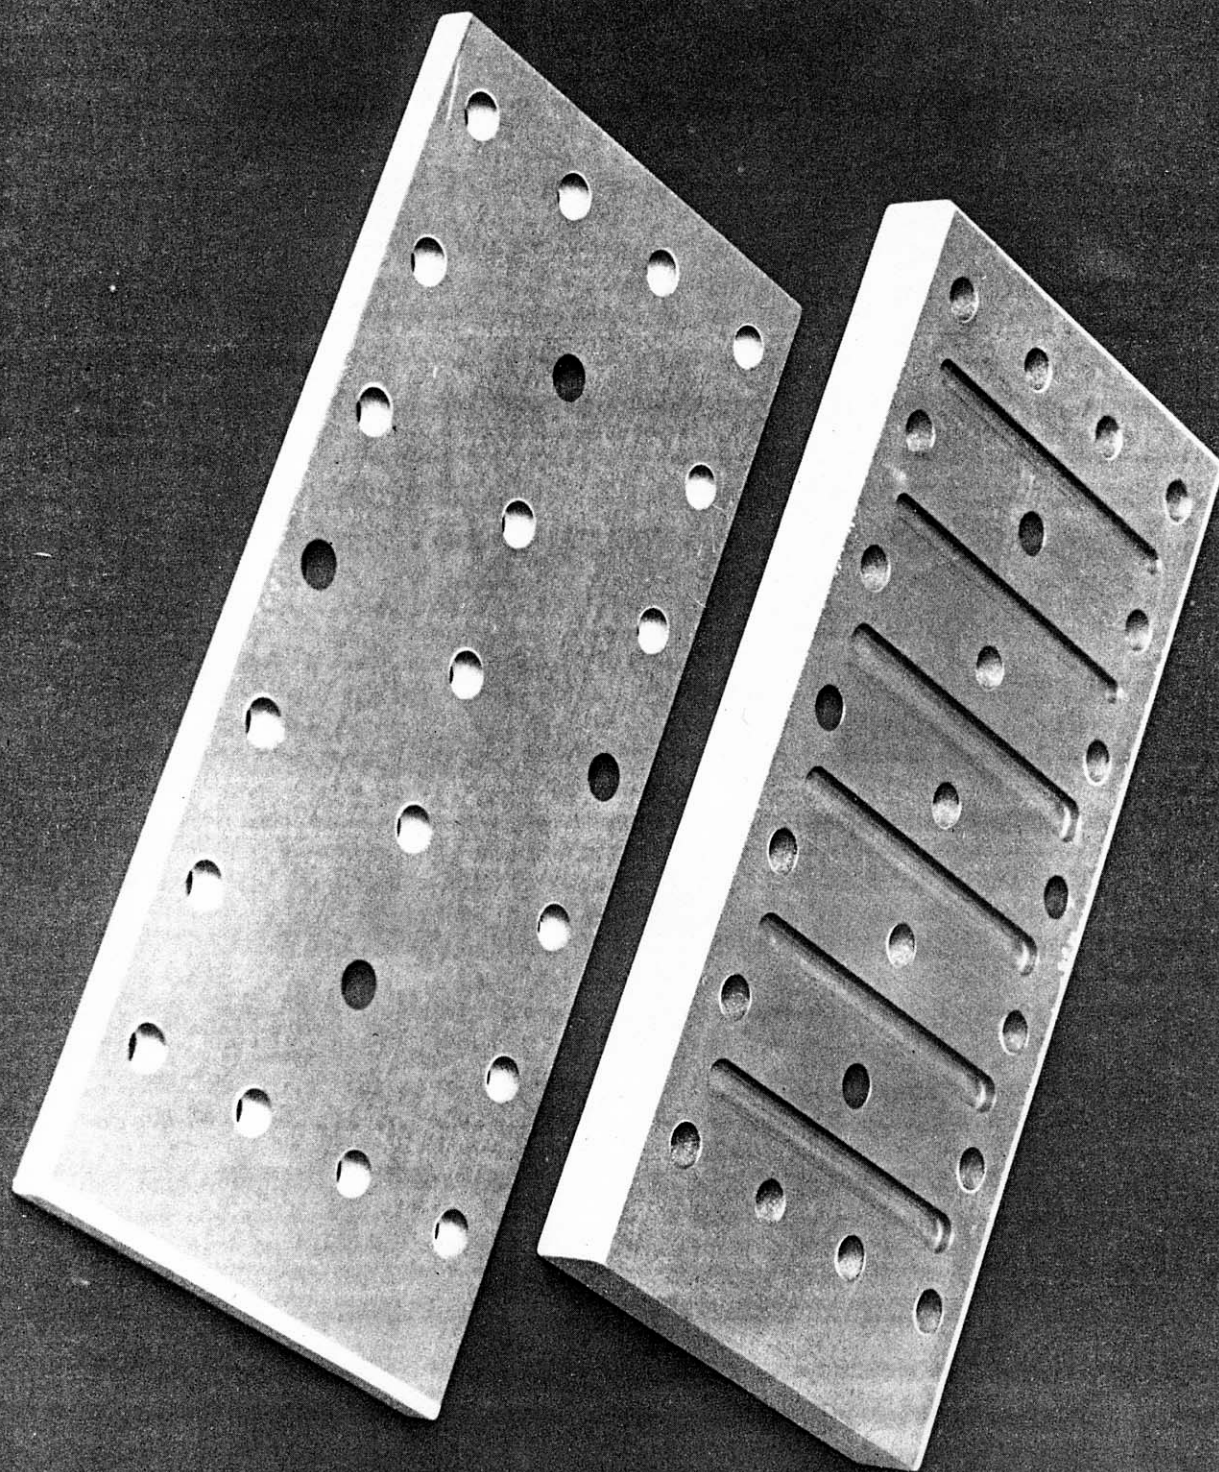
Seven base plate fixtures, 3.5 in. by 7.4 in., were machined to hold six gaskets, each, with one groove being the control (no gasket), Figure 1. The base plate material was 6061-T651 aluminum which represented the MGCS Frame.

FIGURE 1. OPEN FIXTURE, SHOWING GASKET GROOVES.  
BEFORE ACCELERATED CORROSION TESTING.

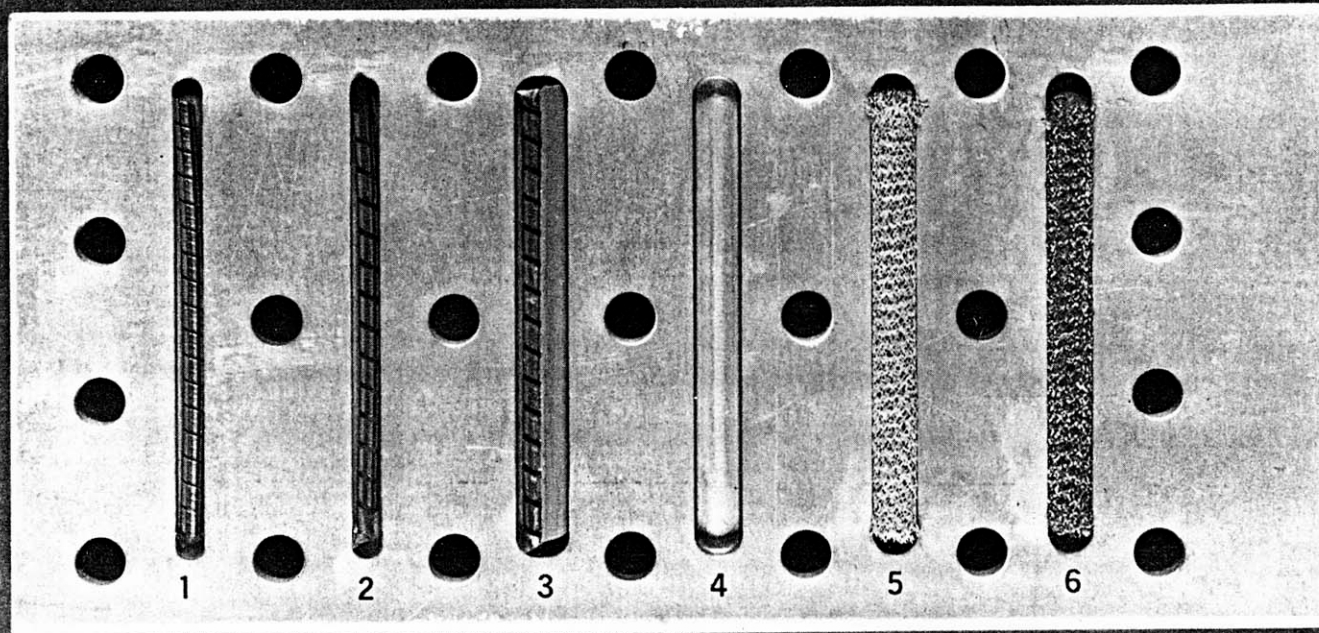
All gaskets were cut and sealed at the edge where cut; except for gaskets in the seven-day salt spray test, Figure 2. The gaskets were placed in fixtures and gapped to 10 mils to represent the gap caused by Ferrex gaskets on assembly of major hardware, Figure 3.

FIGURE 2. FIXTURE WITH GASKETS IN PLACE, BEFORE ACCELERATED CORROSION TESTING.

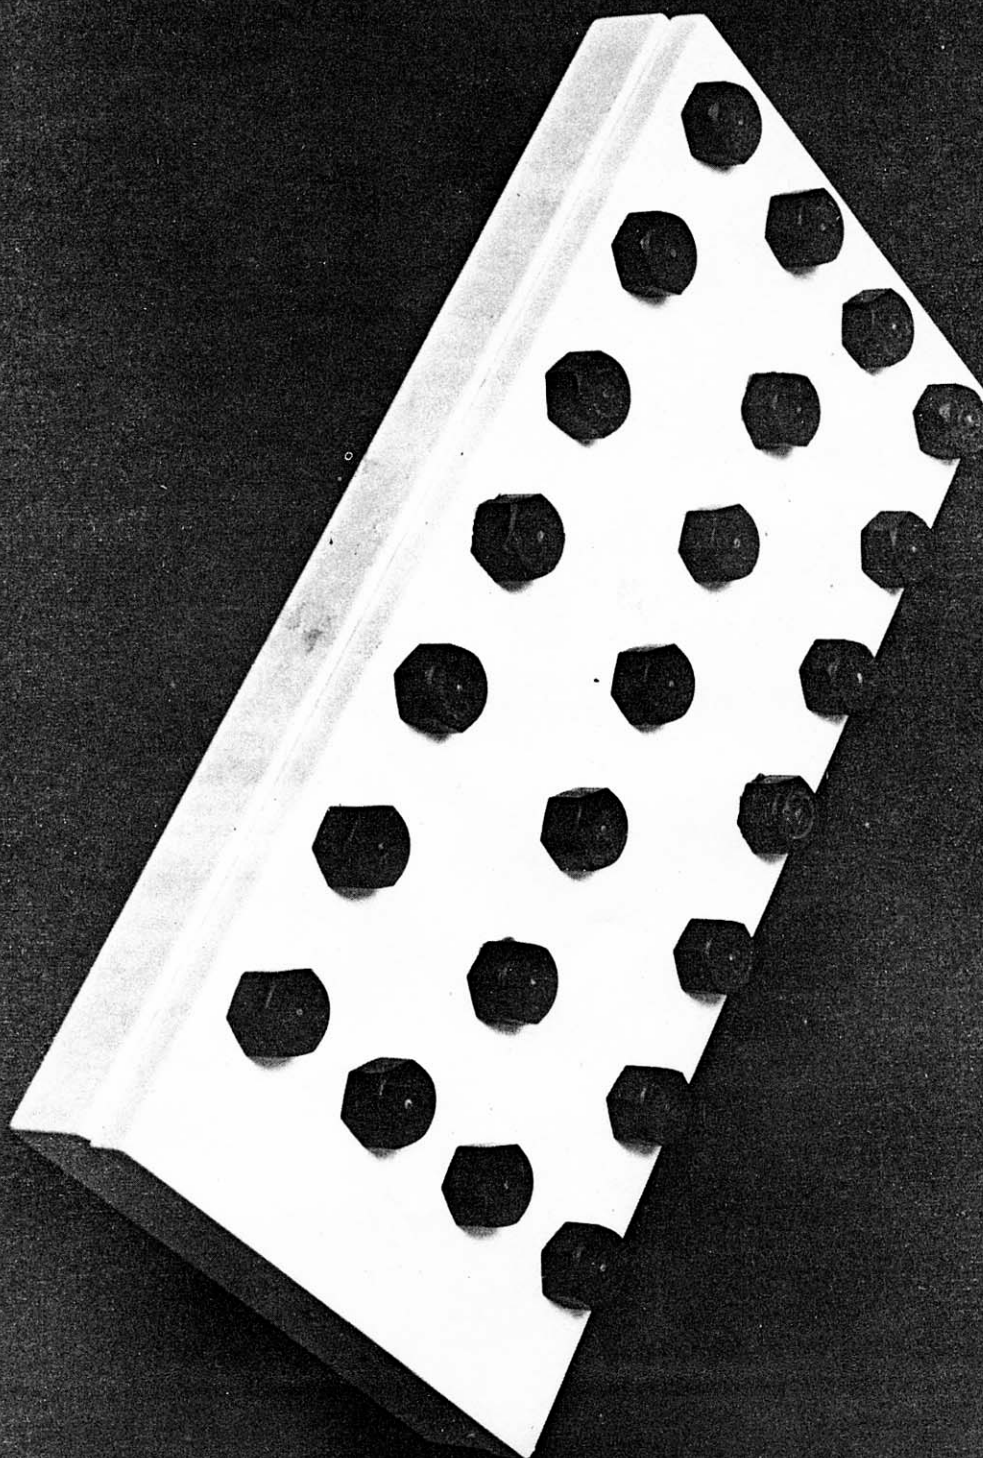
FIGURE 3. ASSEMBLED FIXTURE WITH 10-MIL GAP.
